# **Lybeck Home Inspection Service - Home Inspection Report**

**Inspection Address:** *Street, City, Idaho*

**Date:** *February 28, 2011*

**Inspection #:** *022811A*

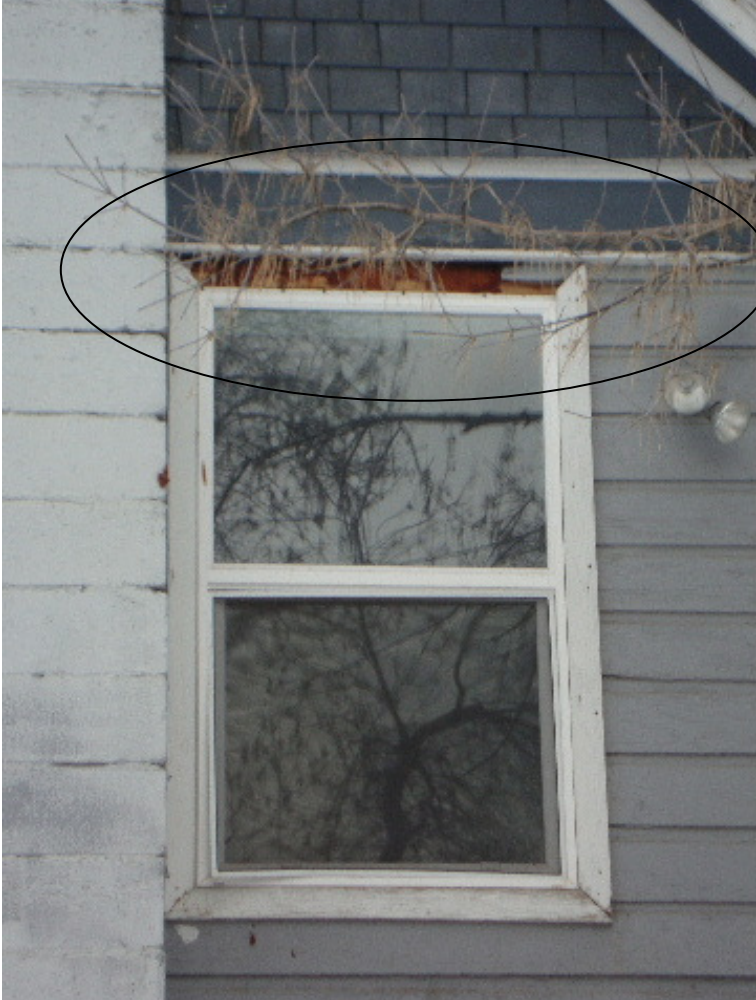
<p><b>3</b></p>	<p><b>Exterior Trim:</b></p> <p>Type: <i>Wood</i></p> <p>Condition: <i>Paint/stain has deteriorated. Trim above the east upper window is missing.</i></p> <p>Comments: <i>Consider minor repair, Consider repair/repaint as needed to ensure longevity.</i></p>

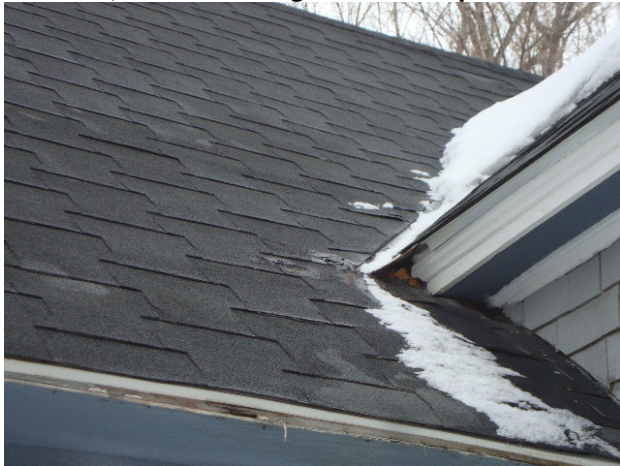
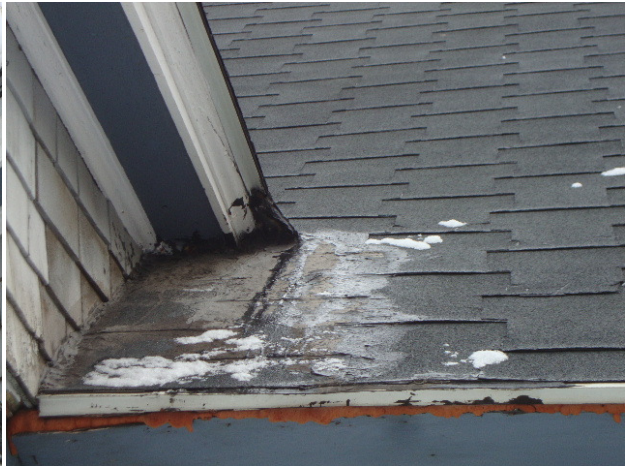
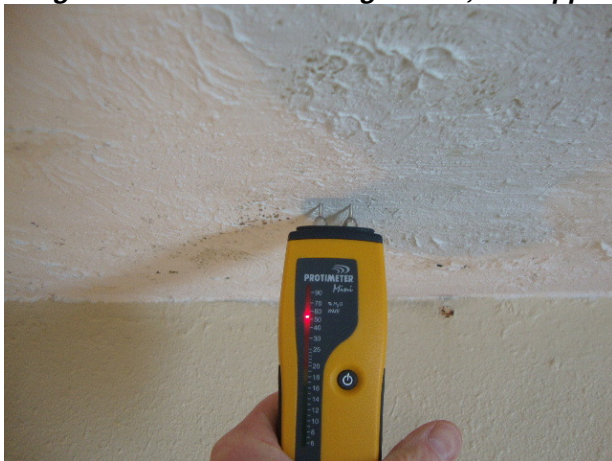
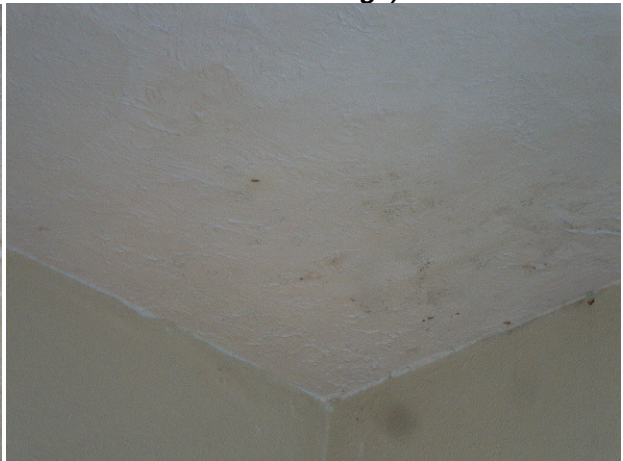
Comments: **Overall the roof appears to be in good shape, shingles overall have minor wear. However, roof is leaking at several spots on the south side.**

**Areas of leakage are in the valleys (and below the valleys) adjacent to the south dormer, and the upper ridge area of the dormer.**

**Moisture is entering the home adjacent to these areas ( dining room south west ceiling corner, living room south east ceiling corner, and upper west bedroom dormer ceiling. )**

**Recommendations:** **Recommend have a reputable roofing company evaluate the roof. (And repair as needed.) Recommend repair of interior walls and ceiling as needed.**

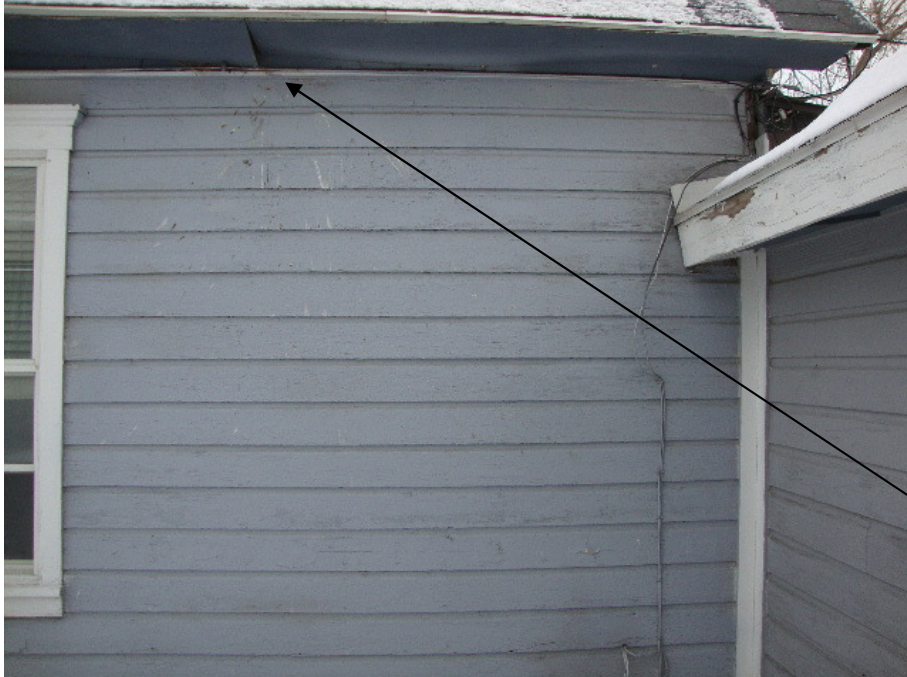
Condition: **Damage - Minor** Loose and deteriorated in a few areas

Comments: **Recommend repair to reduce risk of insect and pest intrusion into home.**

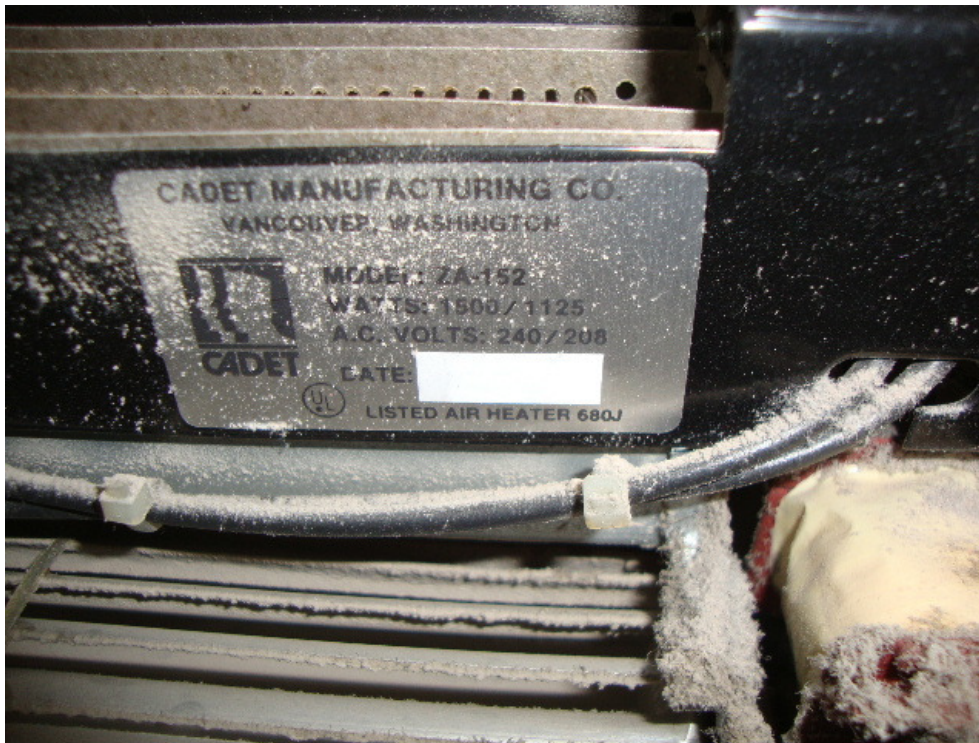
**Upper west bedroom: Cadet ZA-152 Functioning normally, but this heater is recalled by the manufacturer due to fire hazard. (There are 2 of these heaters in this room.)**

**See more information regarding recalled Cadet heaters in the back of the report.**

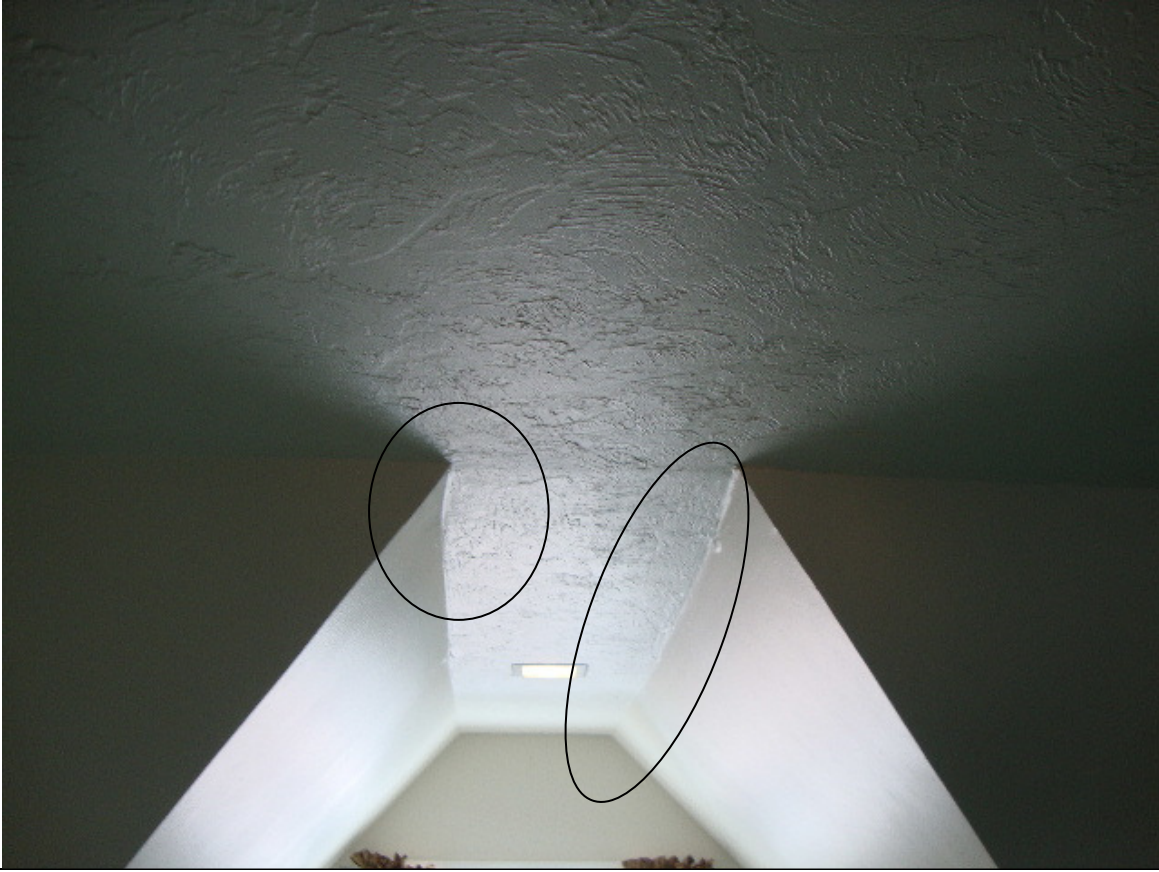
<p><b>1</b></p>	<p><b>Door(s):</b>          Door Condition: <i>Good</i>          Latch(s) Condition: <i>Good</i>          Comments: <i>None</i></p>	<p><b>No Problem</b></p>
<p><b>2</b></p>	<p><b>Ceiling:</b>          Comments: <i>Appear to be in good condition. but the dormer has moisture in the ceiling .</i></p>

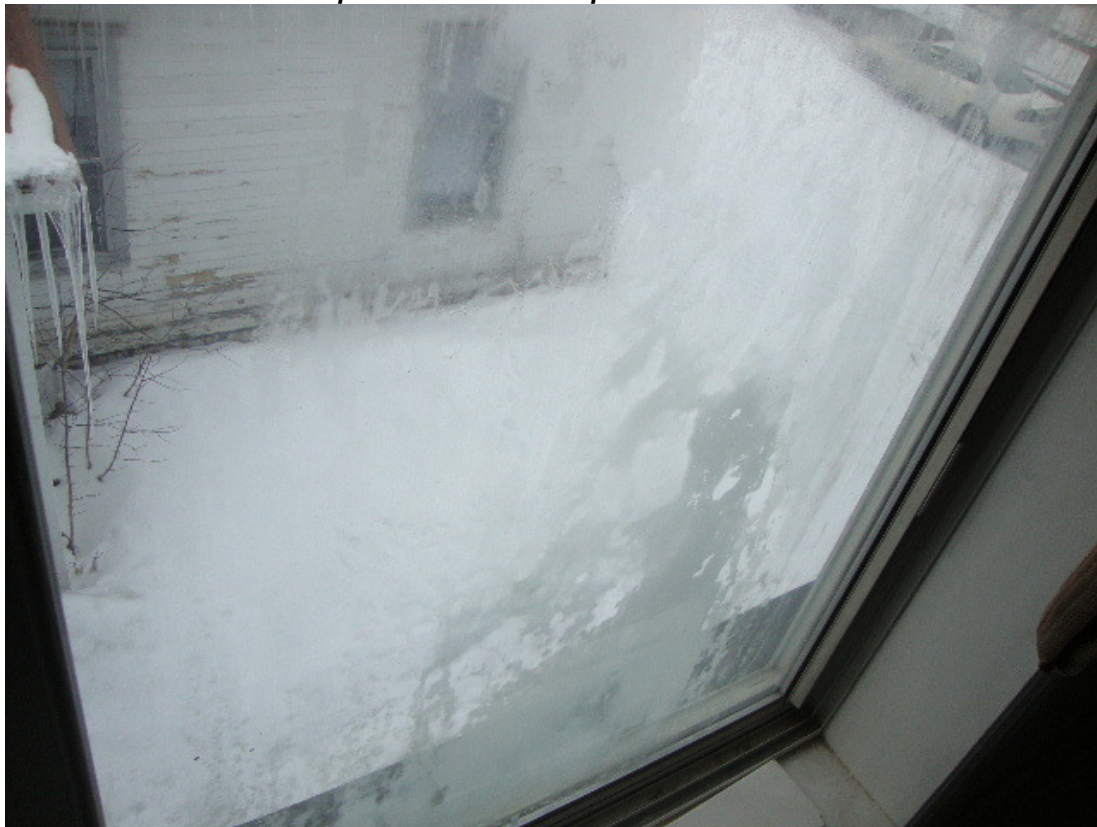
Pane Condition: **"Fogged" due to internal seal failure. Consider replacing, for optical clarity.  
1 storm pane is missing (located in storage room, and is cracked)**

Comments: **Consider replacement and/or repair.**
